NBSIR 76-1025

Air-Mobility Rigid Shelter Systems

November 1975

An Interim Report

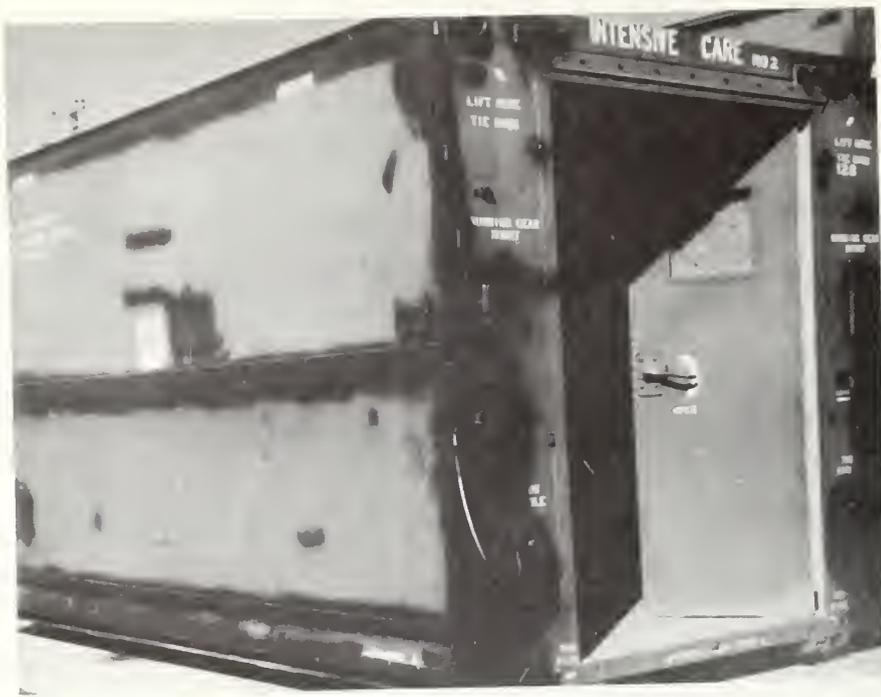
These shelters were made from honeycomb panels and many panels had delaminations (figure 2.32) which made the shelters unusable for their purpose. All of the MUST shelters inspected appeared to be well-used and were about 5 years old. There were punctures in the facings of some panels, predominantly in floor panels (figure 2.33), but no correlation between these punctures and delaminations could be found. In fact, the punctured panel of figure 2.33 was not delaminated. It should be noted that punctures are normally repaired by field personnel and it is possible that the delaminated panels did have punctures at some time.

Fig. 2.13 MUST Ward Container

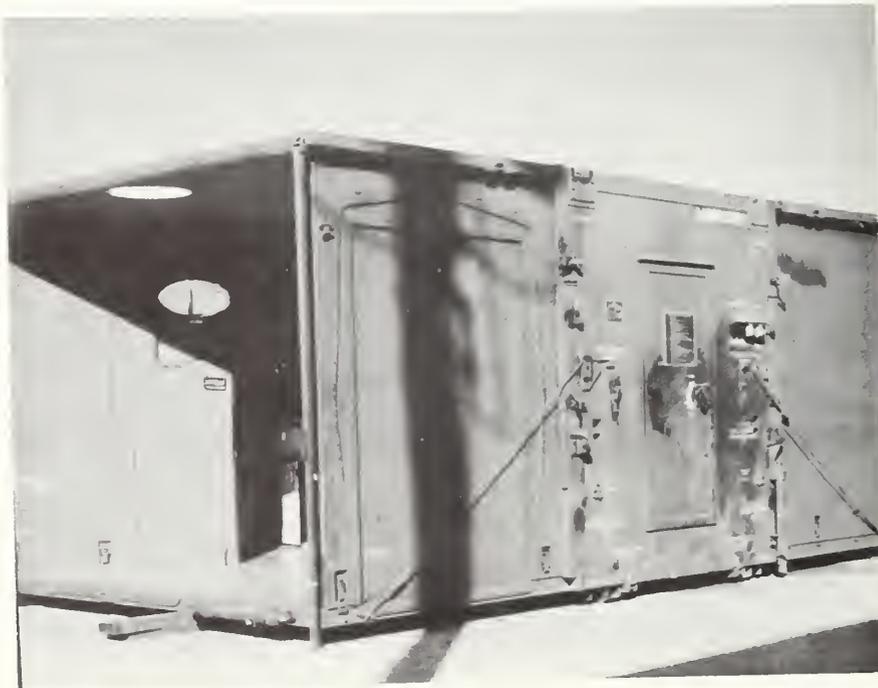
Fig. 2.14 MUST Expandable Shelter

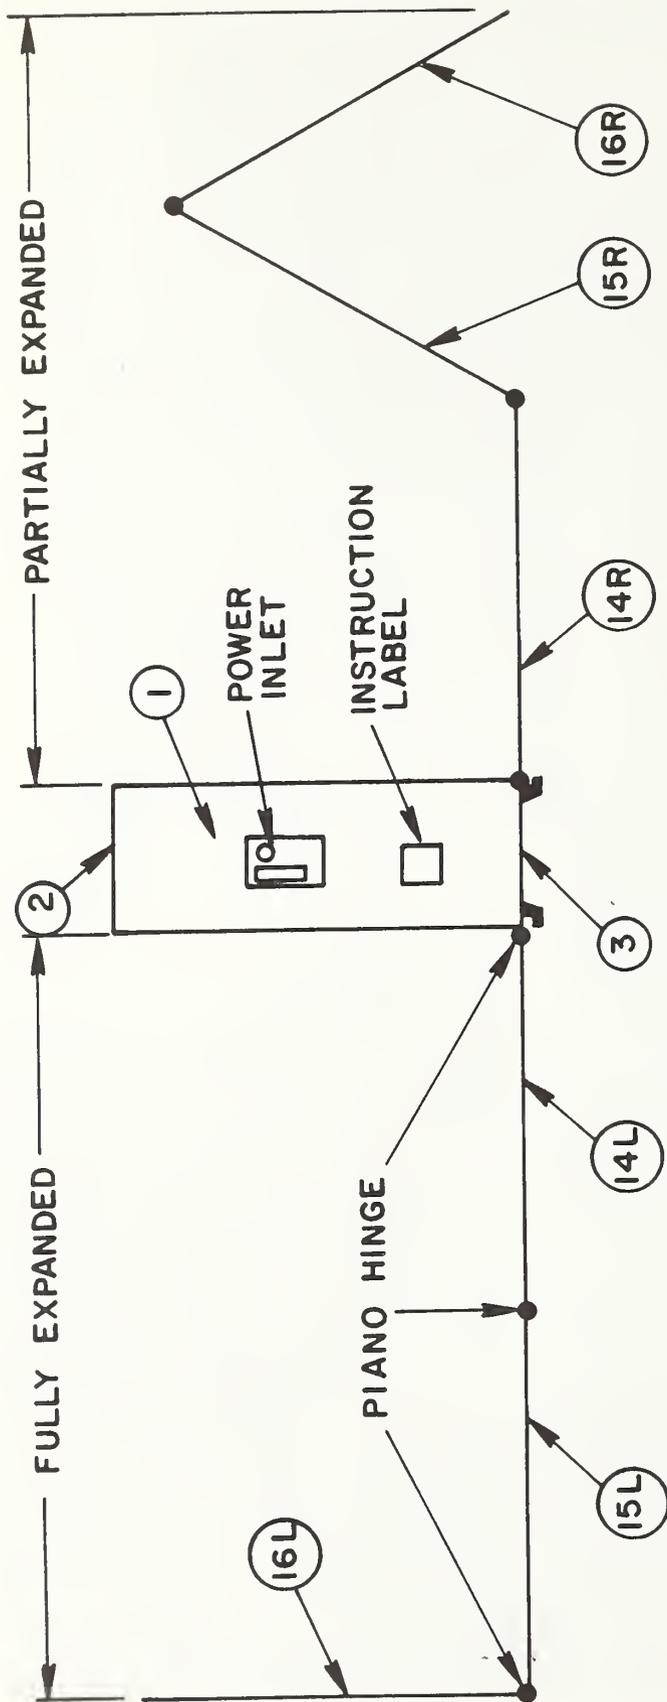
EXP RIGID PANEL IDENTIFICATION, FRONT VIEW OF CENTER STRUCTURE
 (NO.4 PANEL IS BACK PANEL OF CENTER STRUCTURE)

Figure 3.2 is a schematic drawing which indicates the panel numbering system used for this study. Figures 3.7, 3.8, and 3.9 are drawings of individual panels and show the delaminated areas (cross hatched) on each. The numbers in the squares outlined by the grid lines were used to identify samples cut from the panels.

Fig. 3.2 Schematic of EXP shelter with identification of individual panels

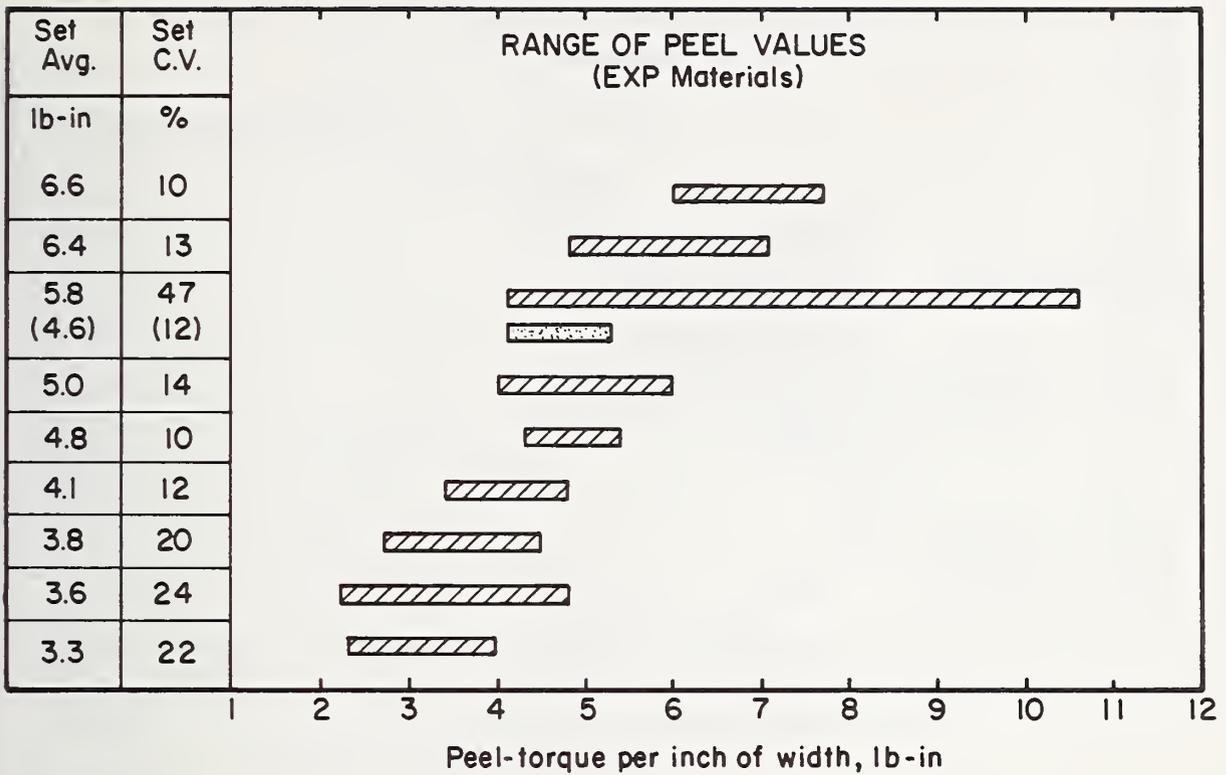
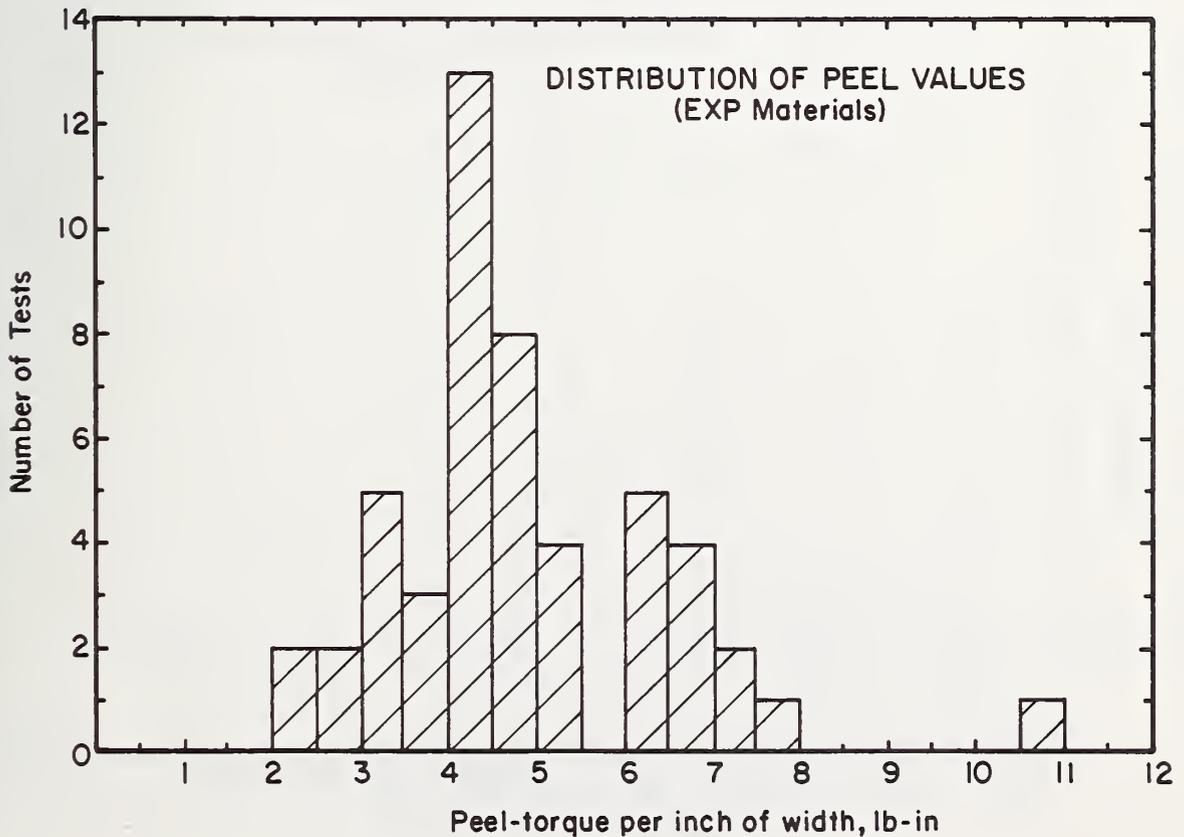
A summary of the peel test results for the honeycomb panel specimens is given in table 3.1. The range and distribution of the individual test values are shown on figure 3.19. Table 3.2 lists the individual test values determined on the facing materials. The data of table 3.2 points out the necessity of measuring the bending load on actual facings when evaluating peel strength of the bond.

One peel test specimen gave an abnormally high value (10.6 in-lb/in). Close inspection of this specimen revealed that it had a double-thickness of adhesive over most of its area. This specimen is included in the table 3.1 and figure 3.19 data for the set with an average of 5.8 lb-in. The average for this set with the abnormal value deleted was 4.6 lb-in. as indicated by parenthesis in table 3.1.

Fig. 3.19 Distribution and range of individual values for peel tests on EXP panel material

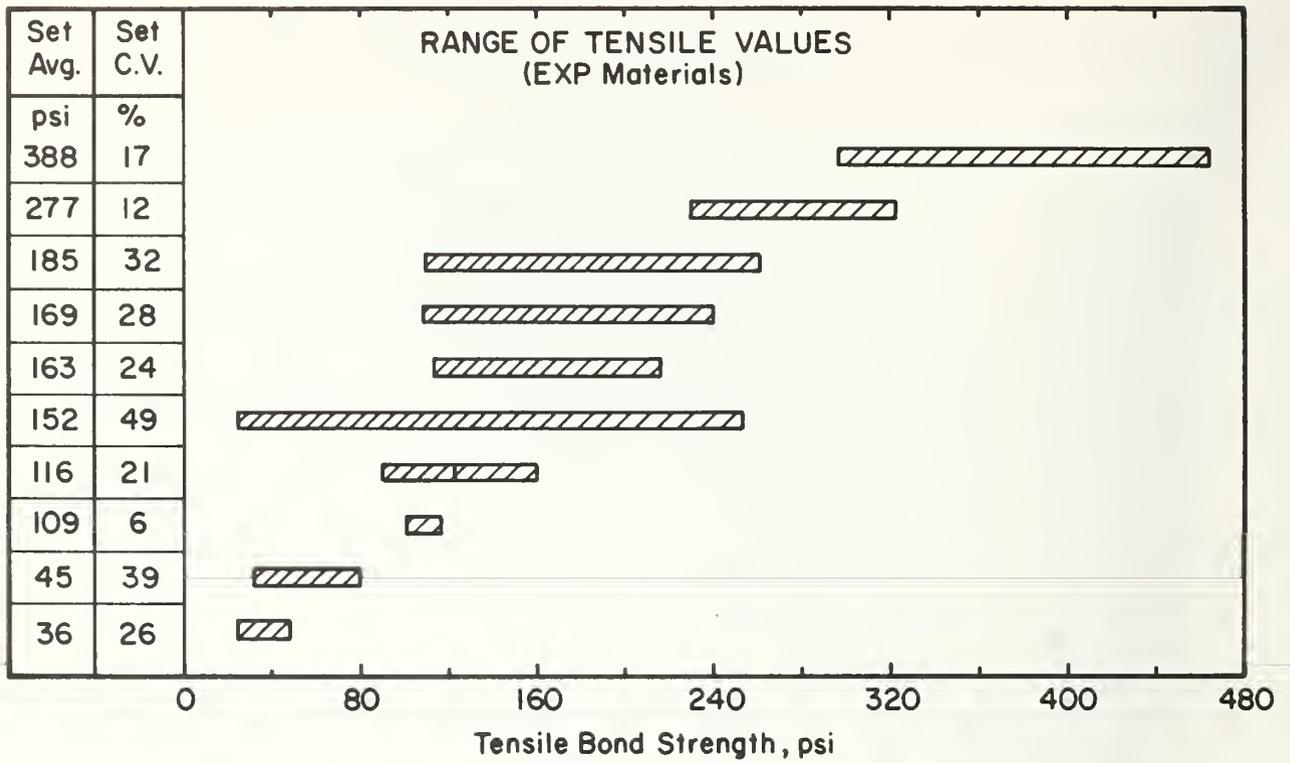
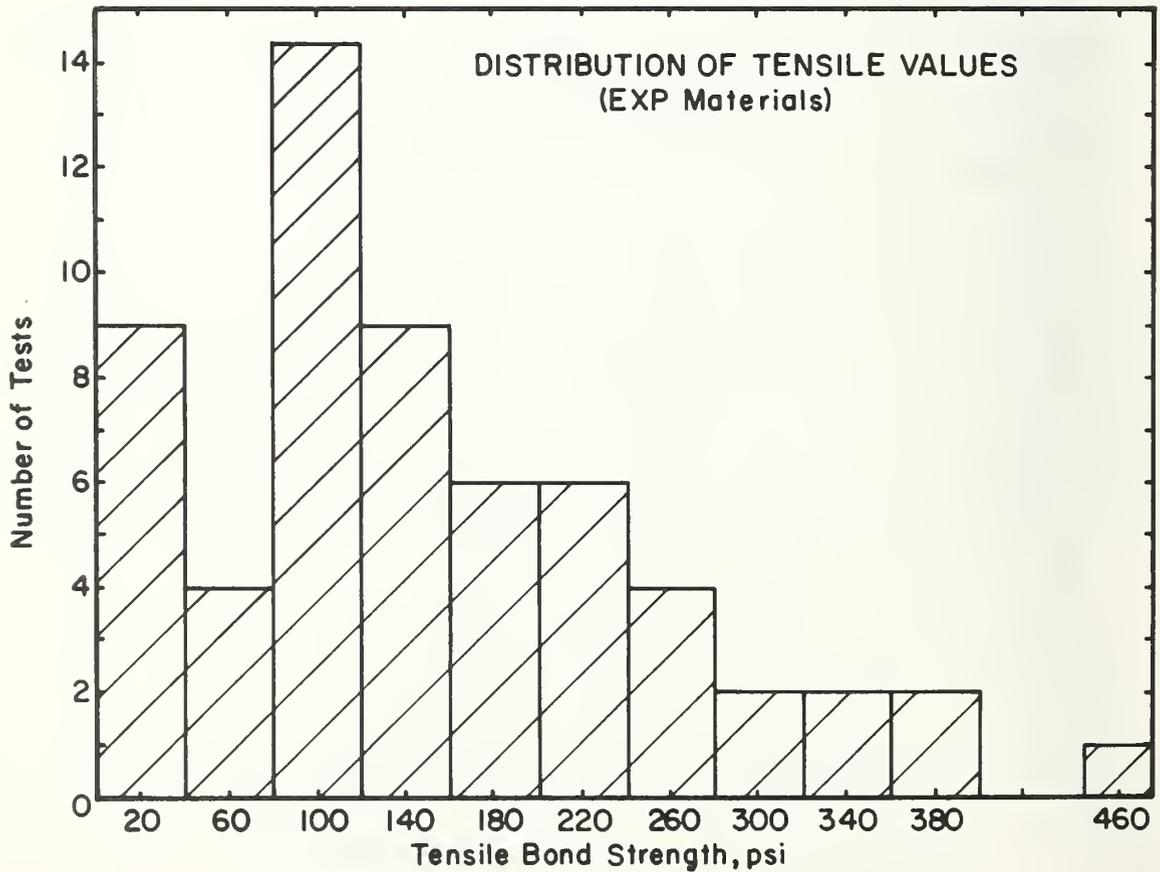
The range and distribution of the individual test values are shown in figure 3.20.

Fig. 3.20 Distribution and range of individual values for tensile tests on EXP panel material

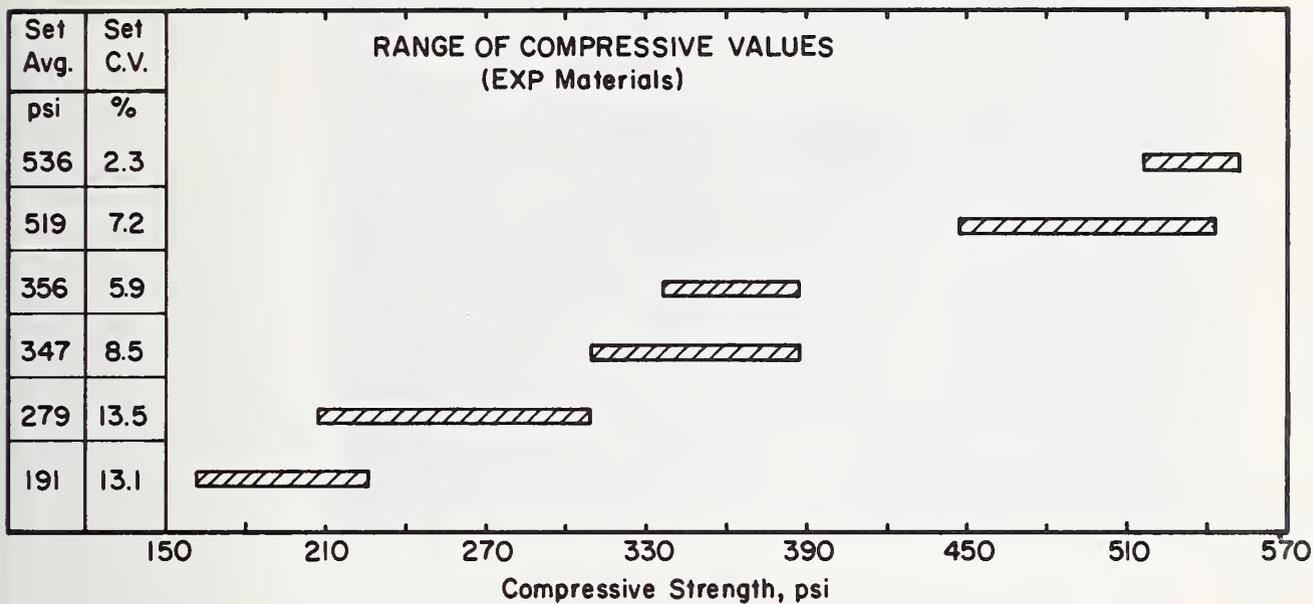
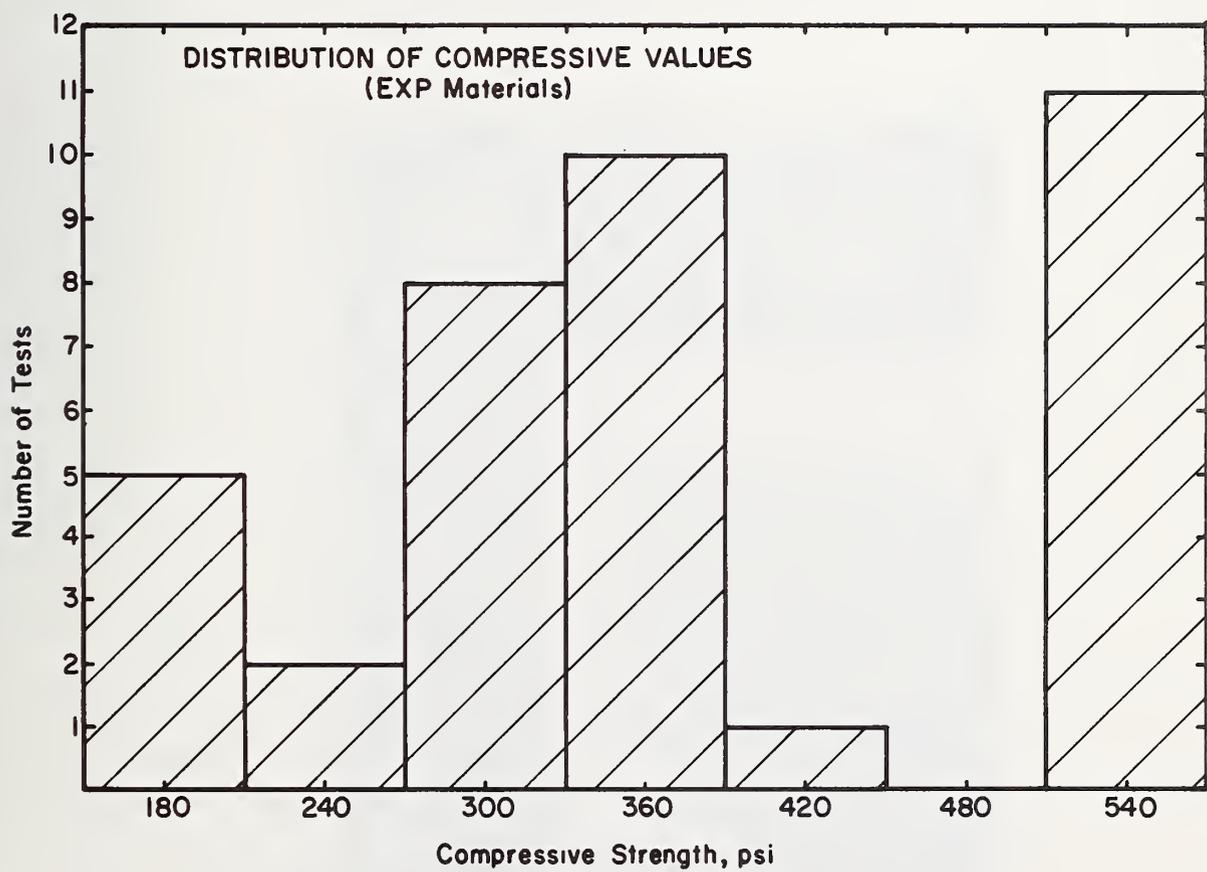
The summary for the compressive test results on honeycomb specimens is given in table 3.4, and the range in individual values is indicated in figure 3.21. The purpose of these tests was to determine the effect of long-term exposure to water on the strength properties of the honeycomb. The honeycomb of panel 15R looked like new while much of the honeycomb in panel 14R was water-logged, was very dark brown, and looked as if it may have deteriorated. All tests were performed at 73°F.

Fig. 3.21 Distribution and range of individual values for compressive tests on EXP panel material

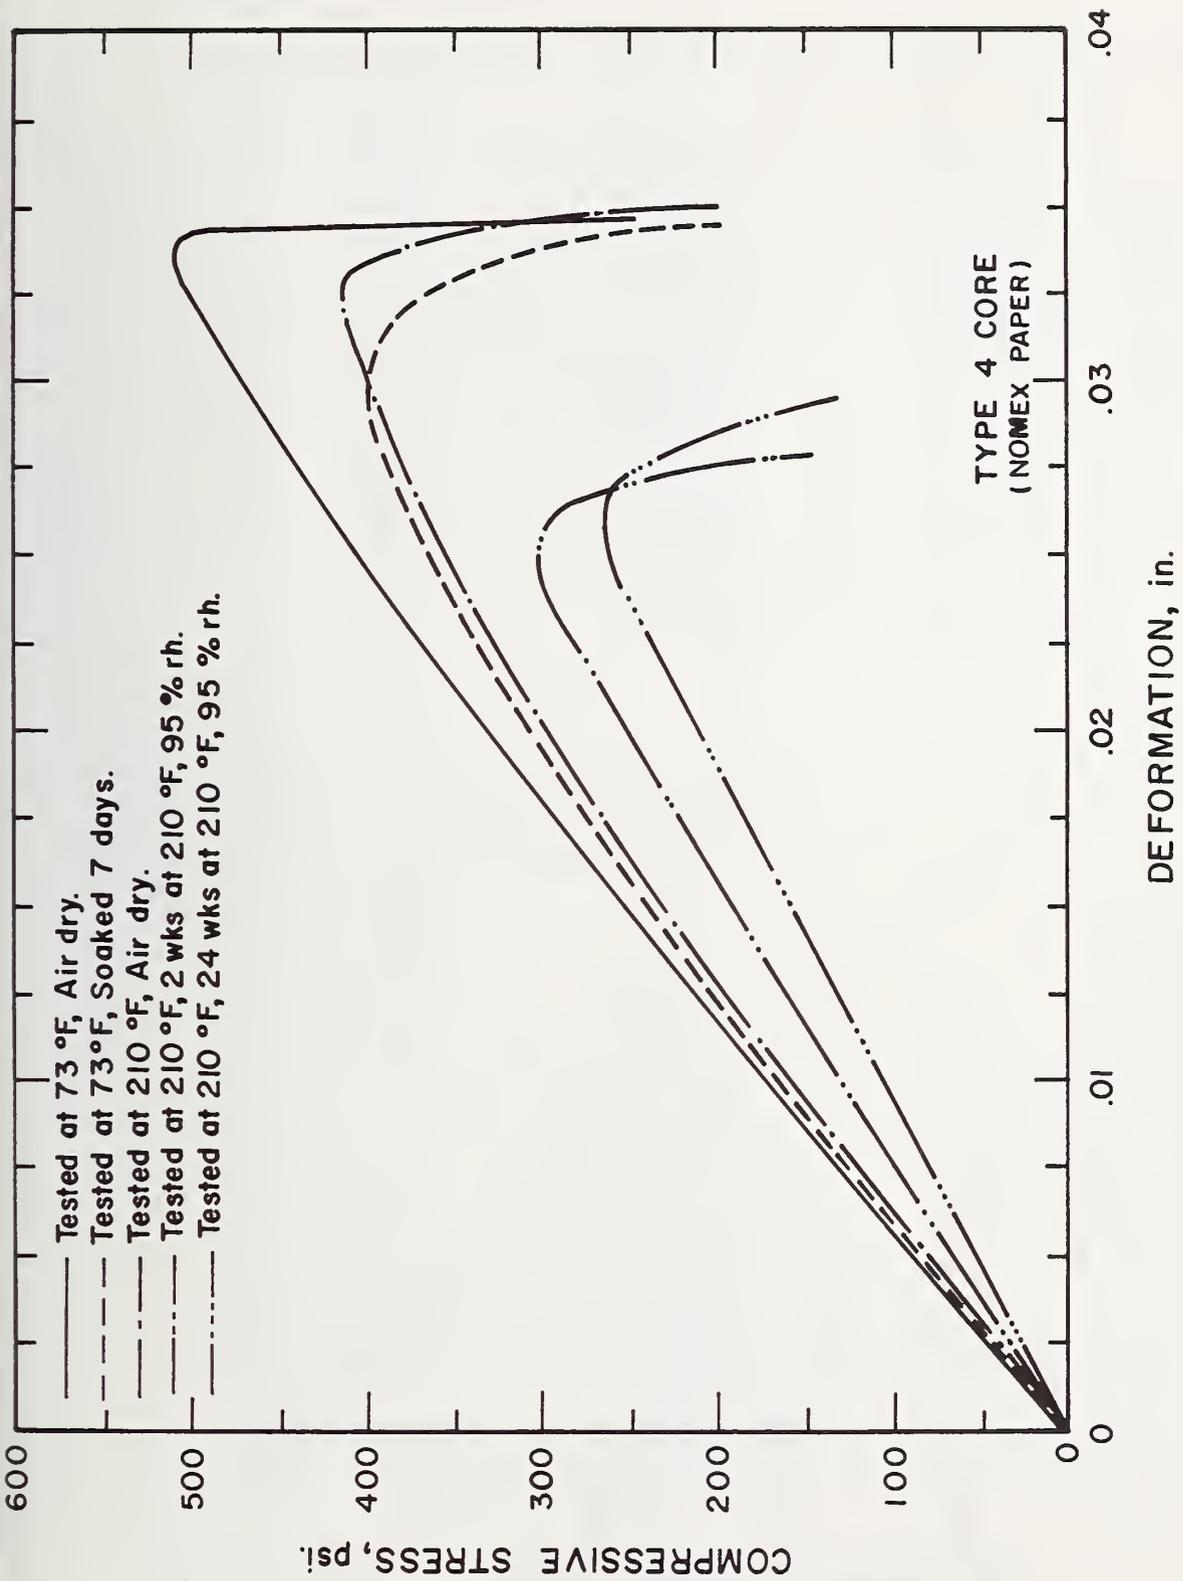
Fig. 4.1 Average stress-deformation data for sets of Type 4 Core specimens

Average test results for each conditioning procedure are presented in table 4.2. Average stress-deformation data for sets of Type 4 and 6 core specimens are shown in figures 4.1 and 4.2.

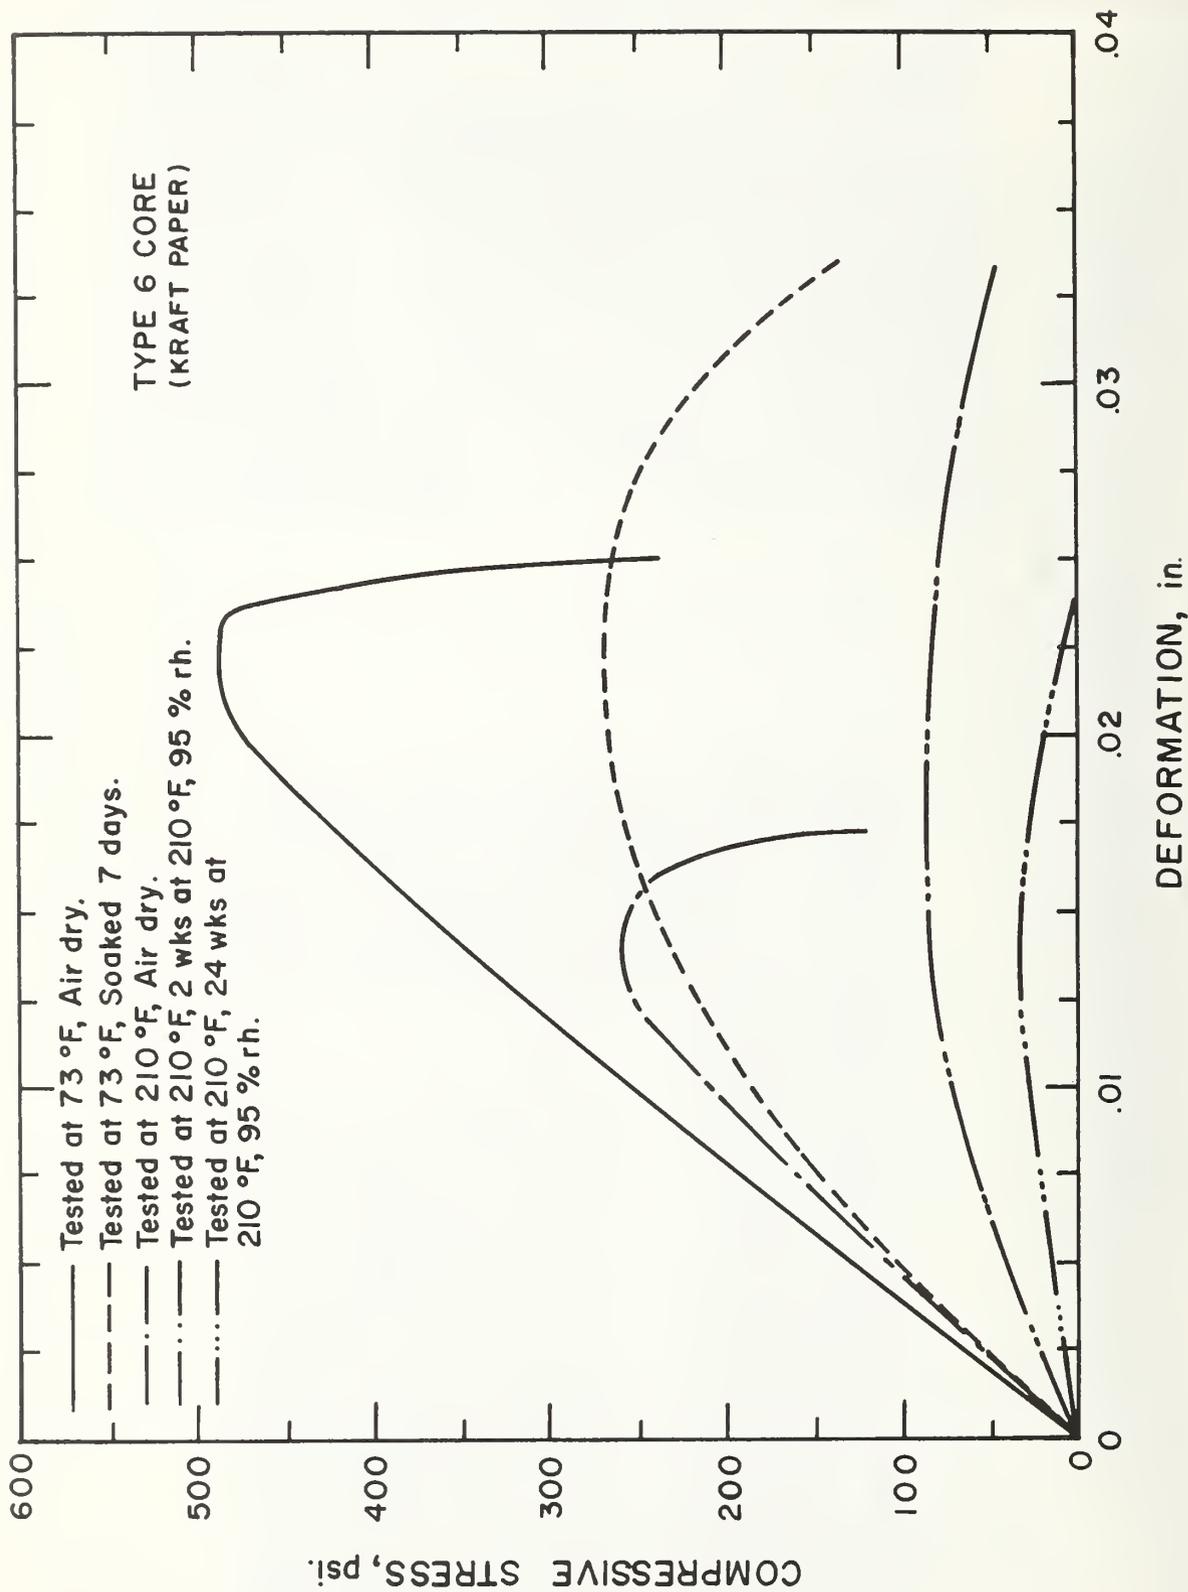
Fig. 4.2 Average stress-deformation data for sets of Type 6 Core specimens

2. Using the relative strength values of table 4.5, the average Nomex core performed better than the WR II by factors as great as 8.3.
3. The strength of the WR II core was too low to have practical value after 24 weeks exposure to high humidity and either 180°F or 210°F. (See table 4.2 or 4.5 and figure 4.2 or 4.3.)

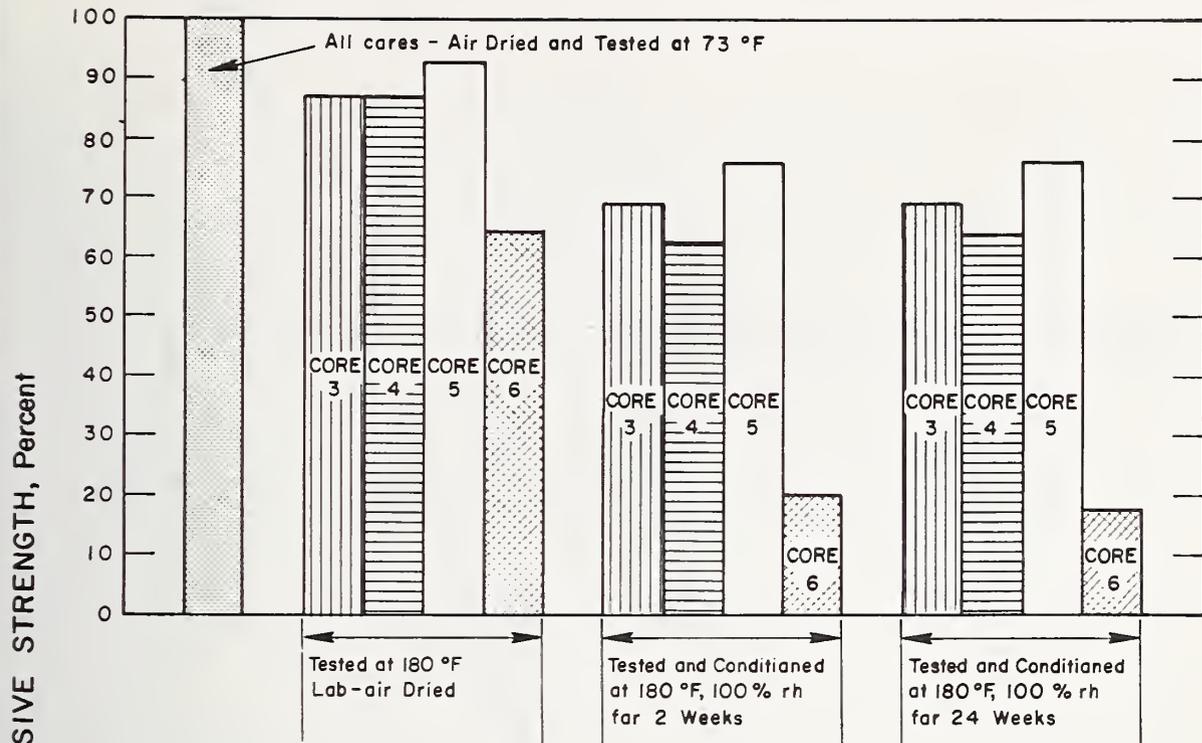
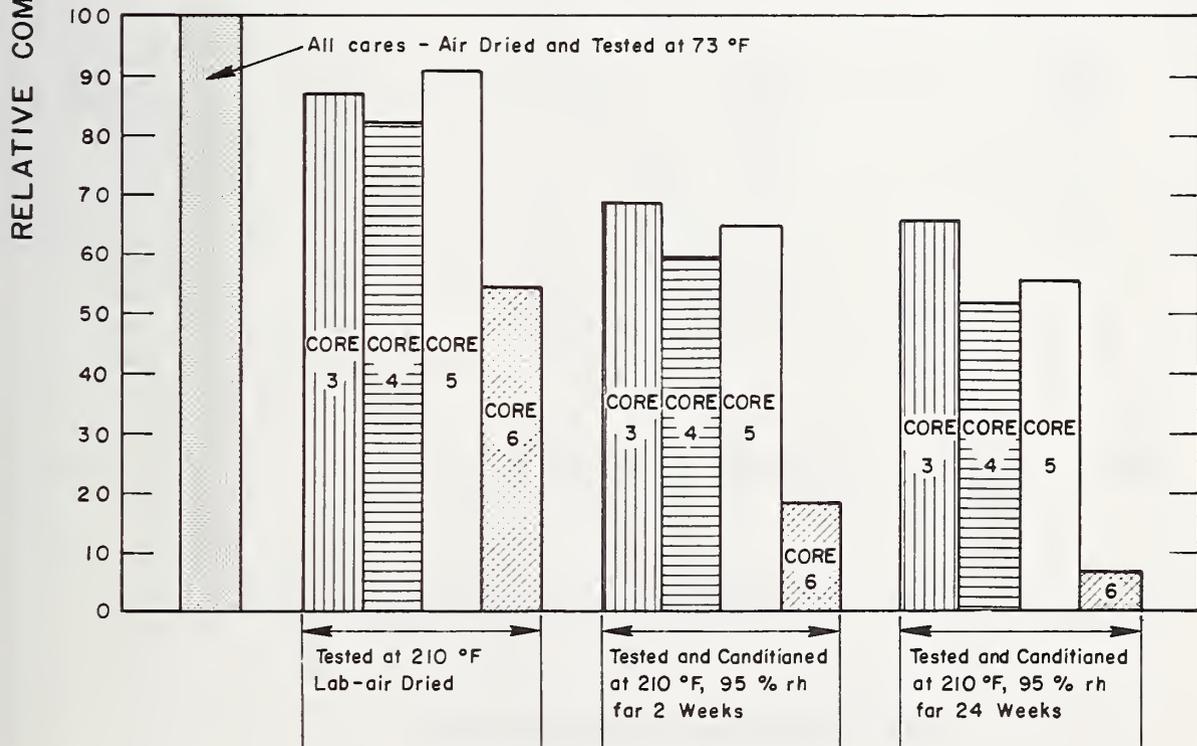
Fig. 4.3 Effect of the conditioning method on the relative strength for the four types of core

The effect of conditioning on strength is shown graphically on figure 4.3 and in table 4.5.

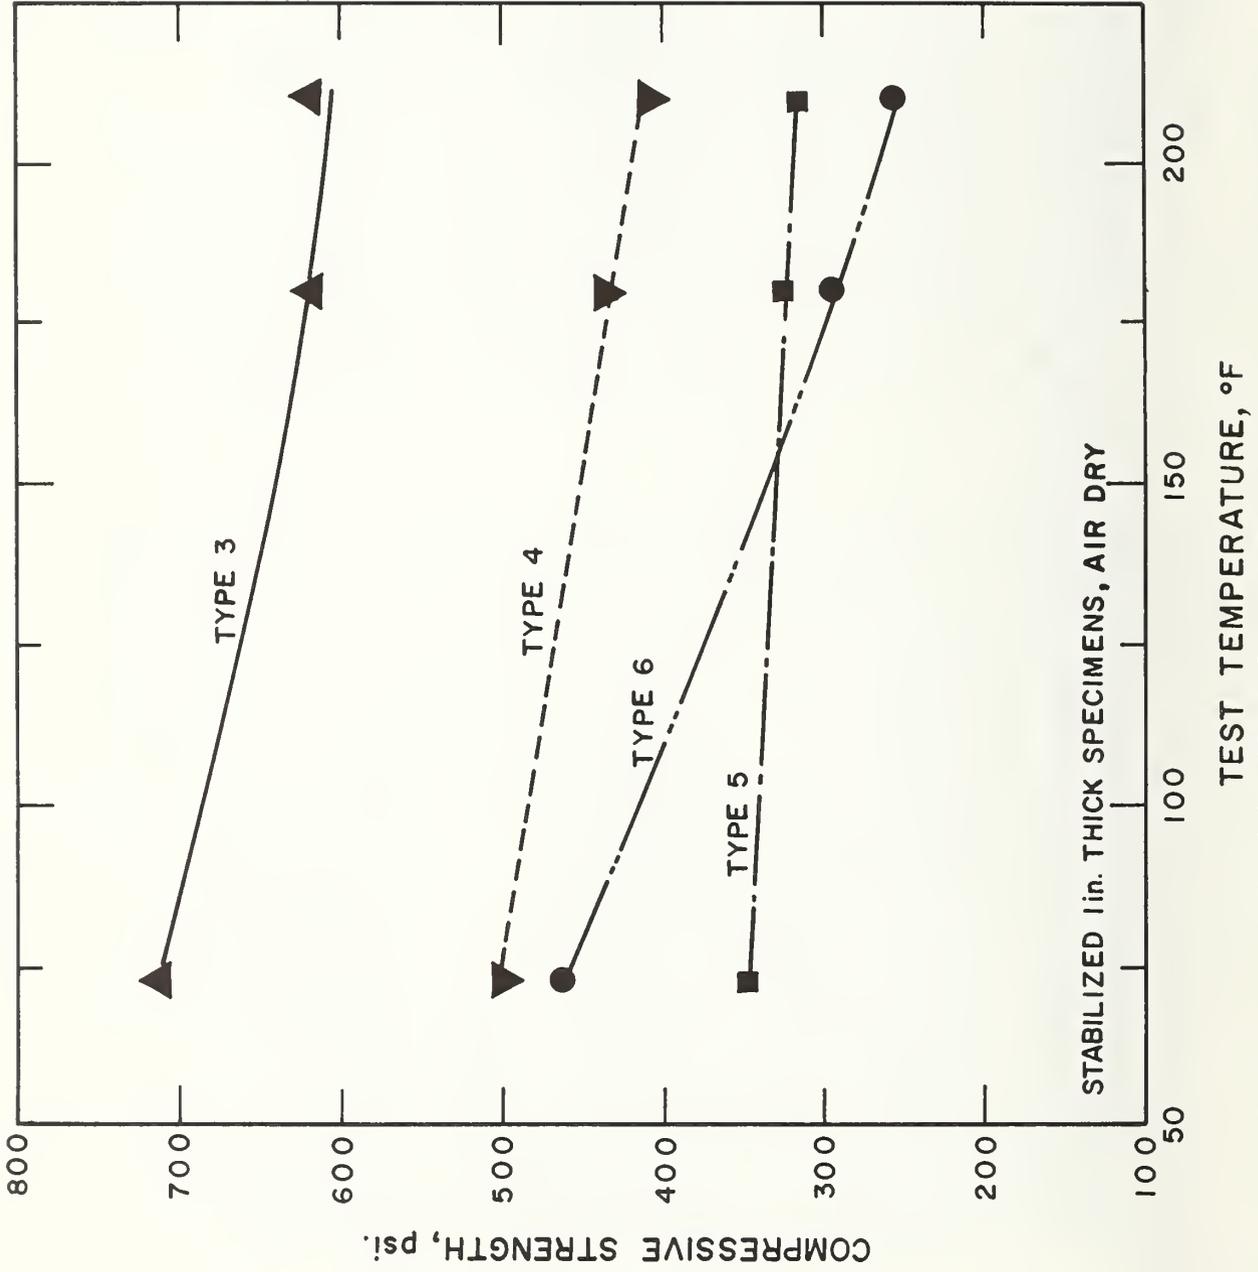
Fig. 4.4 Effect of test temperature on compressive strength for the four types of core

Figure 4.4 indicates the effect of temperature on the strength of air dried specimens. Figure 4.5 shows the effect of temperature on the strength-density relationship.

1. The compressive strengths of the four honeycomb cores varied inversely with the test temperature. (See figure 4.4.) However, the loss in strength for the WR II was about three times greater than for the Nomex cores when the temperature was changed from 73°F to 210°F.

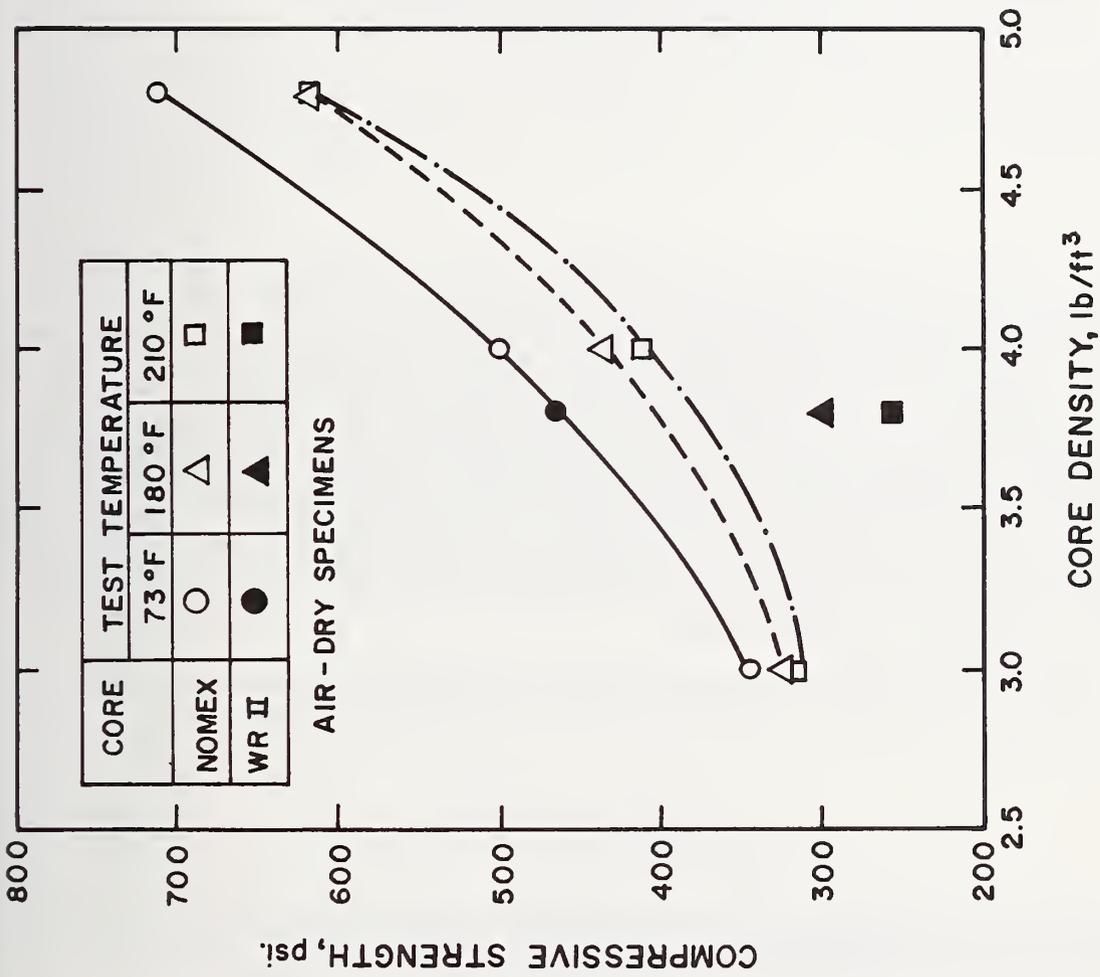
Fig. 4.5 Effect of core density on the compressive strength for the four types of core at various temperatures.

5. The compressive strength of all four cores, in the air-dry condition and at 73°F, are roughly proportional to their air-dry density. (See figure 4.5.) However, at 180°F and 210°F test temperatures, the strength to density ratios for the WR II core are much lower than those for Nomex cores.
